BLACKSTONE RIVER BASIN
WORCESTER, MASSACHUSETTS

QUINSIGAMOND POND DAM
MA 00139

**PHASE I INSPECTION REPORT
NATIONAL DAM INSPECTION PROGRAM**

AUGUST 1978

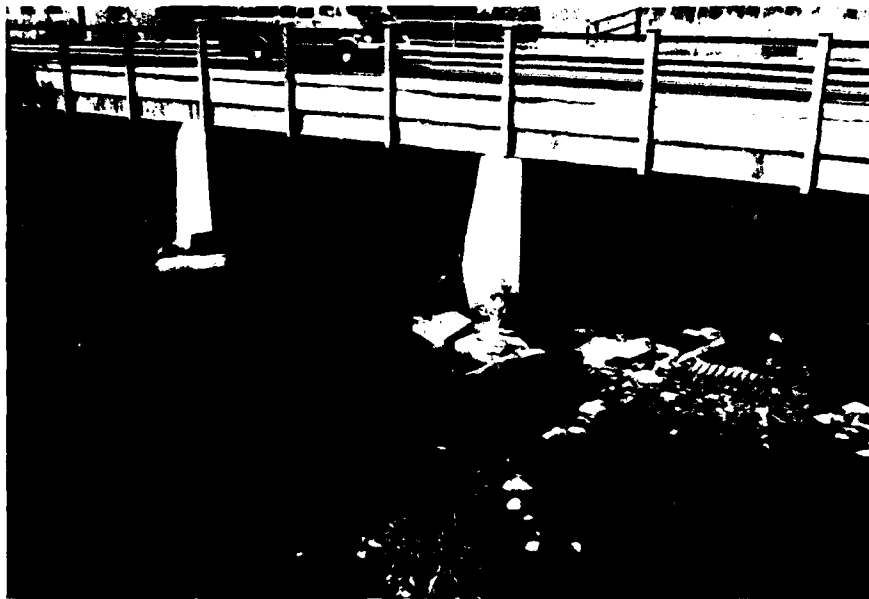
**NO. 3 VIEW OF GREENWOOD STREET BRIDGE
DOWNSTREAM FROM DAM**
